RE: 2nd Revision to PCB Cleanup and Disposal Notification
Joseph A. DePaolo Middle School, 385 Pleasant Street, Southington, CT

**REVISED PCB LOCATION & EXTENT TABLE TO INCLUDE
CONFIRMATION SAMPLE NUMBERS**

ATTACHMENT B
TYPICAL WINDOW COMPONENTS

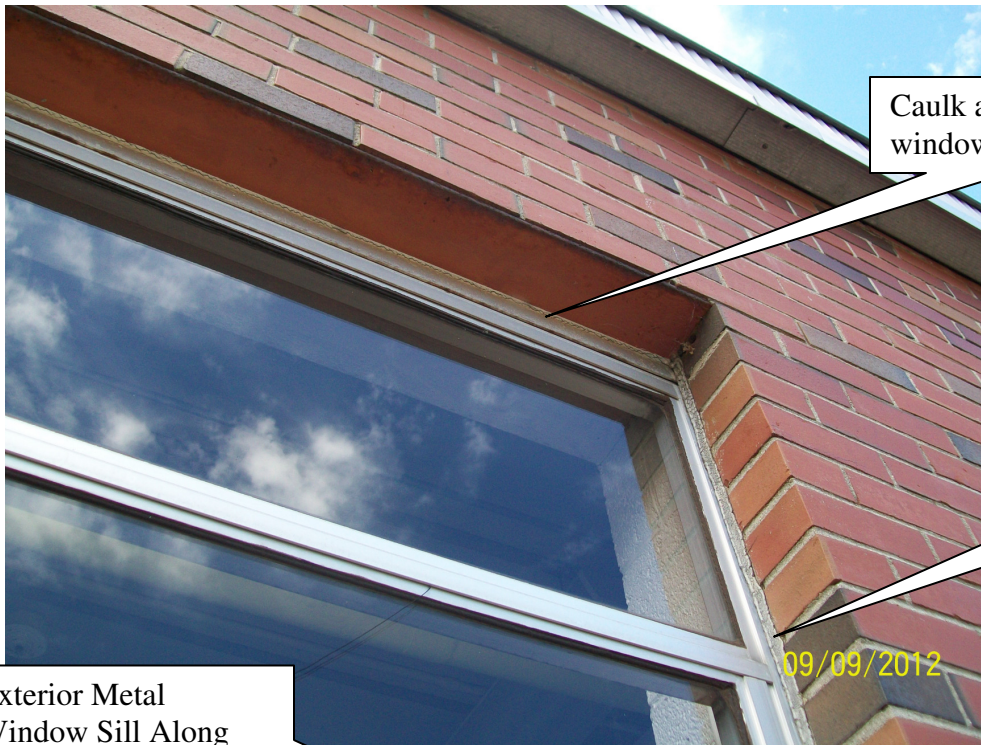
Caulk along top of window on steel lintel.

Caulk along sides of window on brick

Exterior Metal Window Sill Along Base of Window

1. Remove window & metal sill along the base of the window
2. Remove remaining caulk from the steel lintel along the top of the window opening and from the brick on the sides and along the base of the window opening.

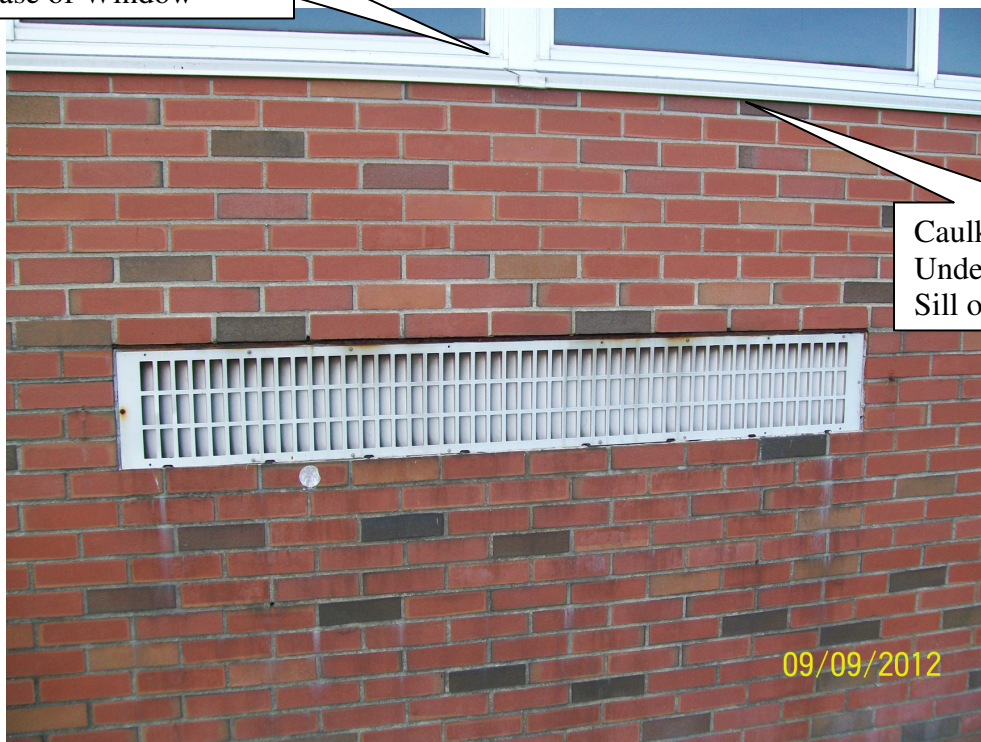
Caulk Removal From Under Metal Window Sill on Brick
